## Industry Case Study

### UNIVERSAL JOINT FOR POULTRY PROCESSING EQUIPMENT

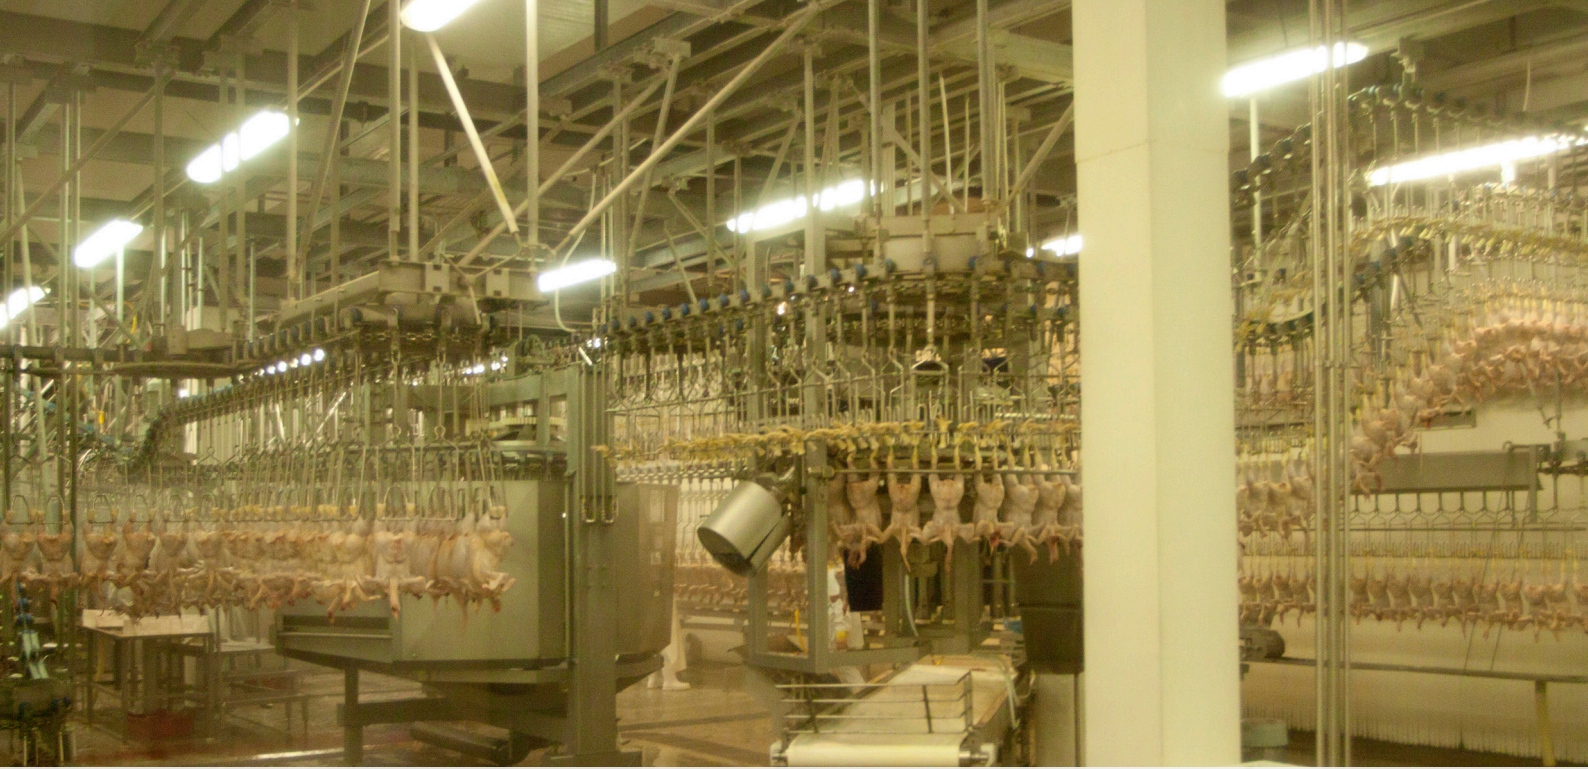
Belden Universal's solution was a needle bearing universal joint with yokes made from 316 grade stainless steel to survive harsh wash-downs. It included blind bores and keyways to enhance strength and prevent corrosion of the cross and bearings; and a silicone boot and food-grade grease to comply with sanitary requirements.

The needle bearing universal joint is available in a wide variety of hub materials. Bores can be customized for any inside diameter and depth to attain a blind configuration, preventing shaft

penetration into the center joint components and providing added protection against contamination. The universal joint assembly can also be passivated to remove impurities. Boot covers are added for gaseous and abrasive environments for enhanced protection of the pins and block or cross and bearing. Food grade grease to ensure cleaner and safer processing is available upon request. Needle bearing universal joints are manufactured in both inch and metric sizes and operating angles up to 45.
